NASA/TM—1998-208659

Space Shuttle Pinhole Formation Mechanism Studies

Nathan S. Jacobson
Lewis Research Center, Cleveland, Ohio

November 1998

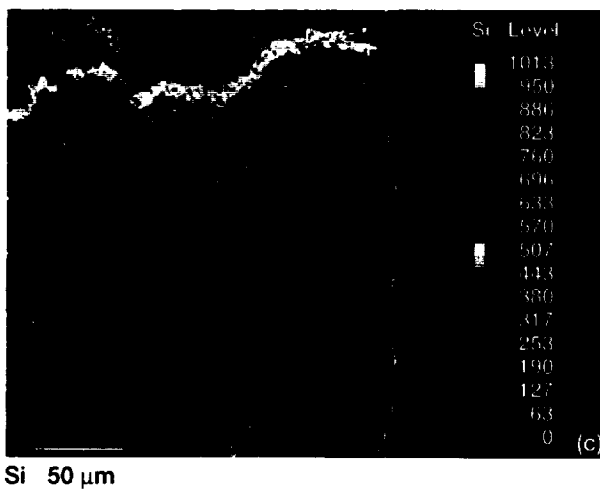
An important issue with this system is the thermal expansion mismatch between the SiC coating and the carbon/carbon. Cracks develop in the SiC coating during processing and also during service. Figure 3 and the associated oxygen map illustrate these two types of cracks. The crack which developed during processing is filled with pure silica, as indicated by the oxygen map. No other elements were detected in this crack. The crack which developed during testing is visible in the image as an open crack.

Figure 3.—Cross section of material, BSE image and associated oxygen WDS map, illustrating a crack formed as-fabricated (filled with SiO_2) and in-service (not filled).

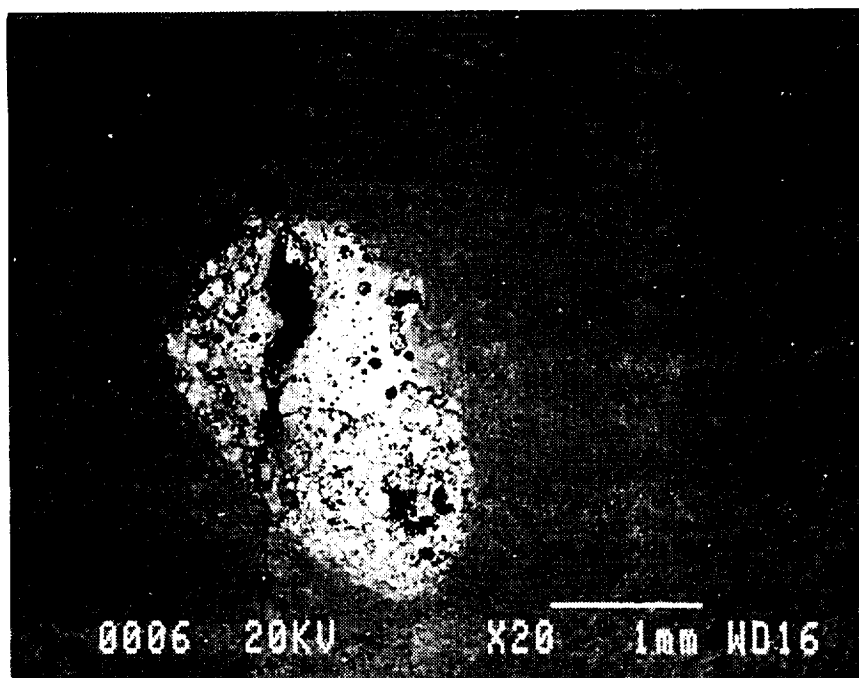
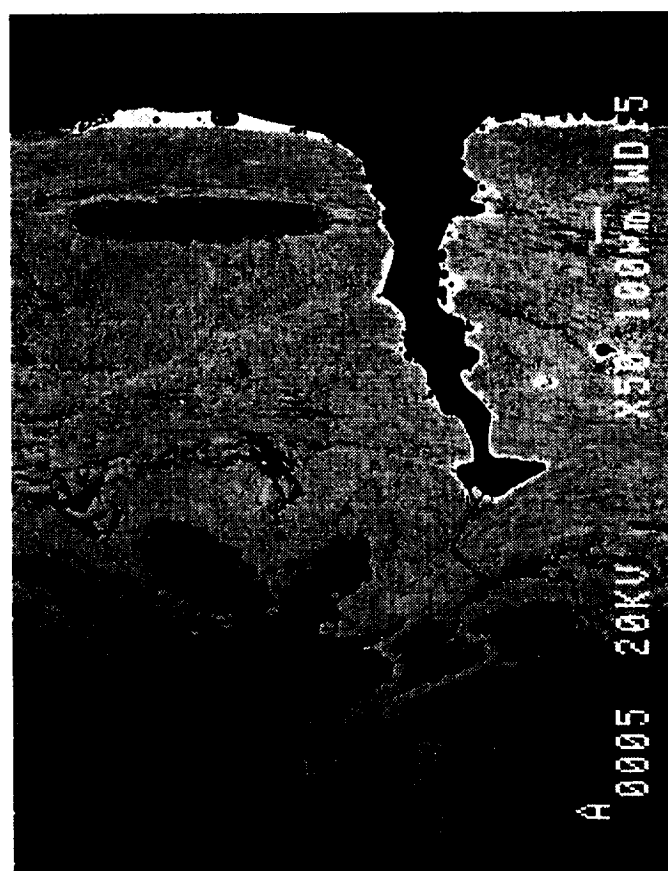
In a BSE image, the phases with heavier elements tend to appear brighter. Elemental identification of these bright phases indicated a large amount of zinc. The source of this zinc is likely the flaking paint from the launch structure. Thus pinholes are always associated with zinc. As pointed out by Christensen (ref. 1), the glass adjacent to the pinhole has a more frothy and bubbly appearance than the glass which normally covers the RCC. The BSE images of the cross sections indicate that the zinc-rich glass flows into the pinholes. In addition the pinholes are nearly always along craze cracks in the SiC. These are formed due to the thermal expansion mismatch between the carbon/carbon and the SiC coating. The cross sections all suggest that the pinhole is simply an enlargement of upper portion of one of these cracks.

Figure 6.—(a) Pinhole from OV-102, Wing Leading Edge Panel 12 RH, 15 flights.
Cross-sectional view is a BSE micrograph.

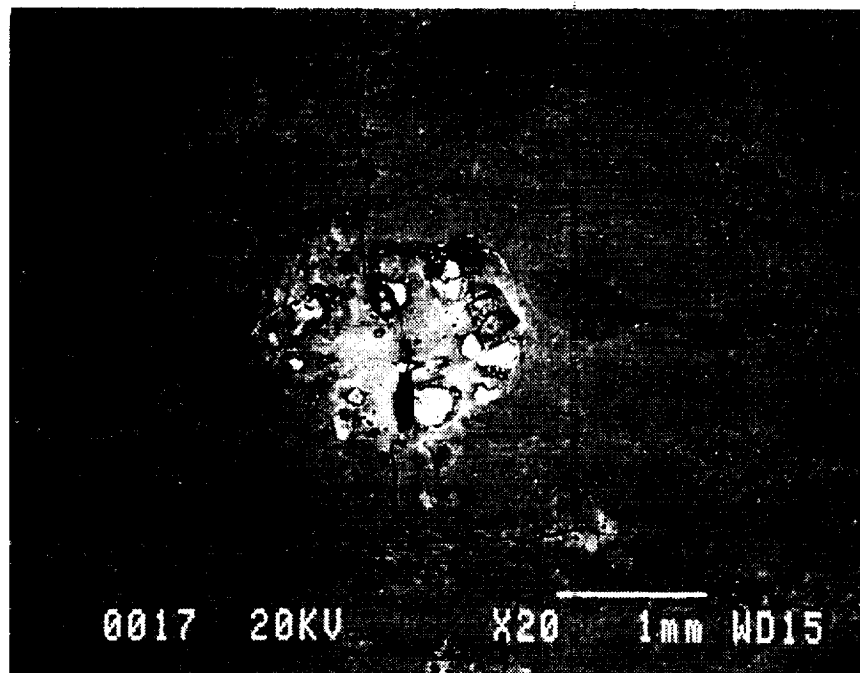
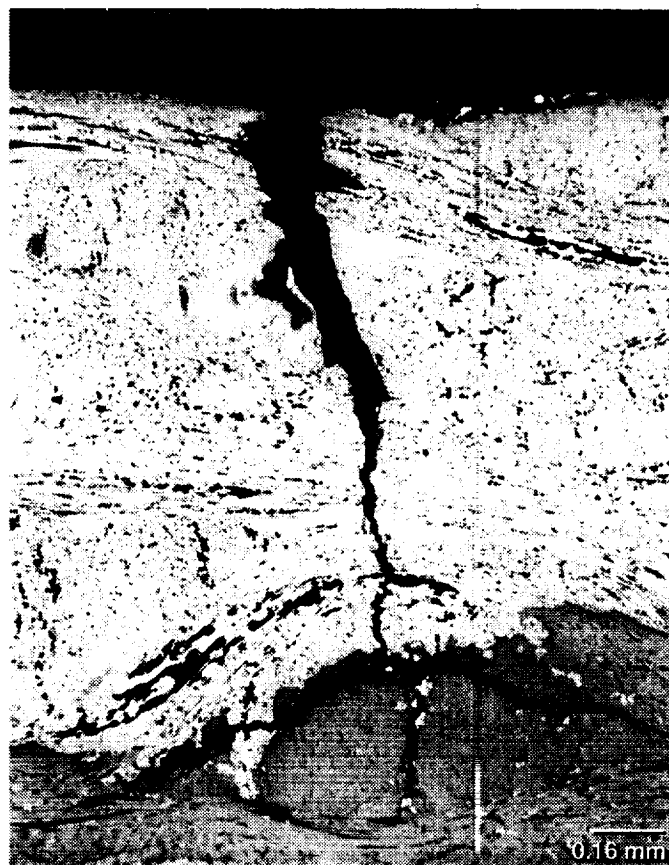
Figure 6.—Continued. (b) Pinhole from OV-102, Wing Leading Edge Panel 12 RH, 15 flights. Cross-sectional view is an optical micrograph.

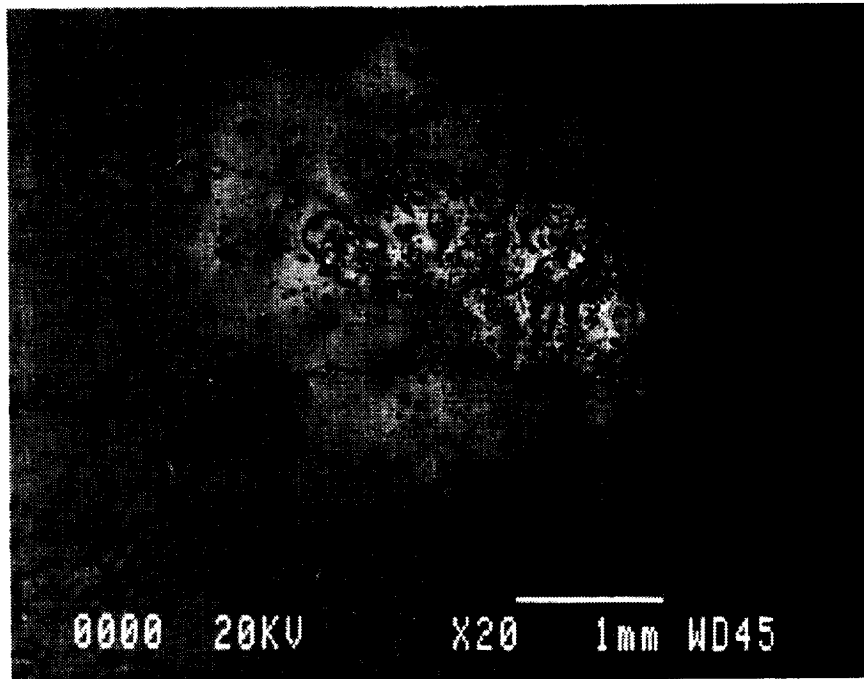
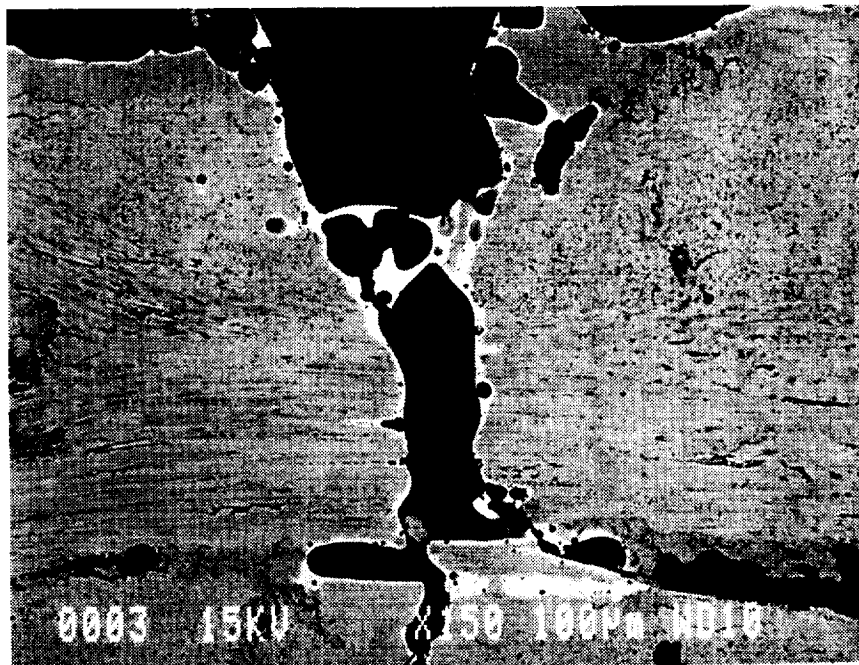
Figure 6.—Continued. (c) from OV-102, Wing Leading Edge Panel 10 LH, 19 flights. The cross-sectional view is a BSE micrograph.

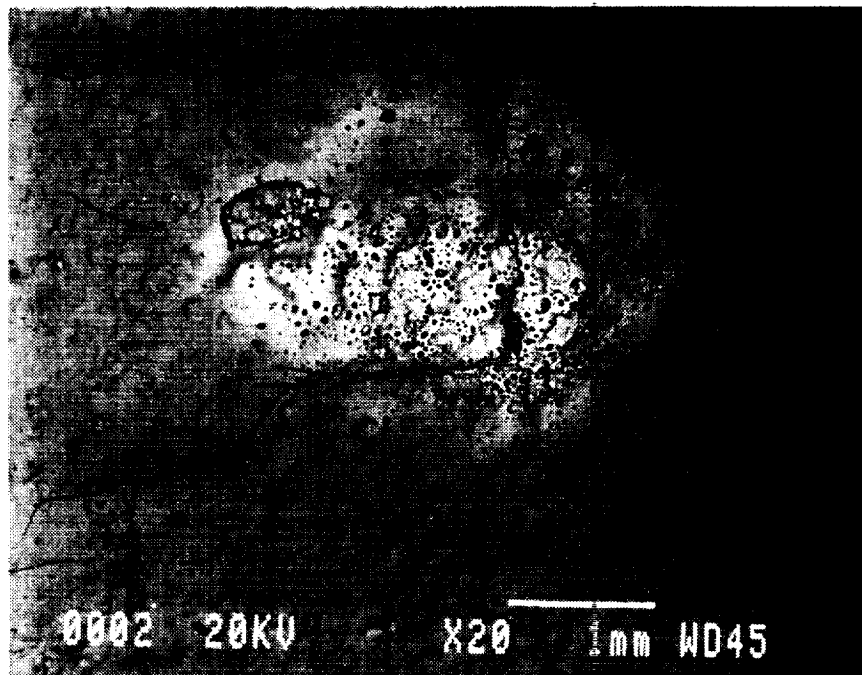
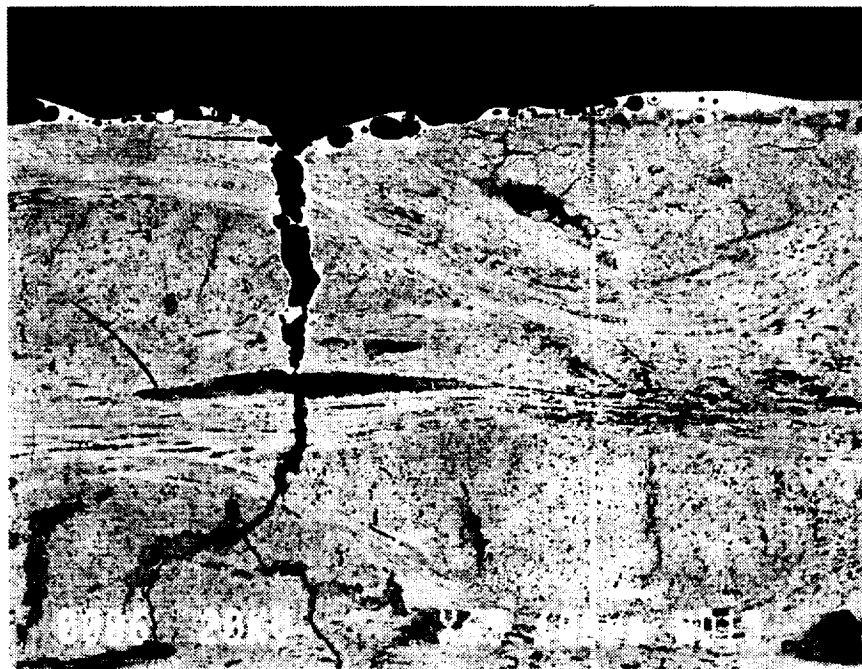
Figure 6.—Continuing. (d) from OV-102, Wing Leading Edge Panel 10 LH, 19 flights. The cross-sectional view is a BSE mic ograph.

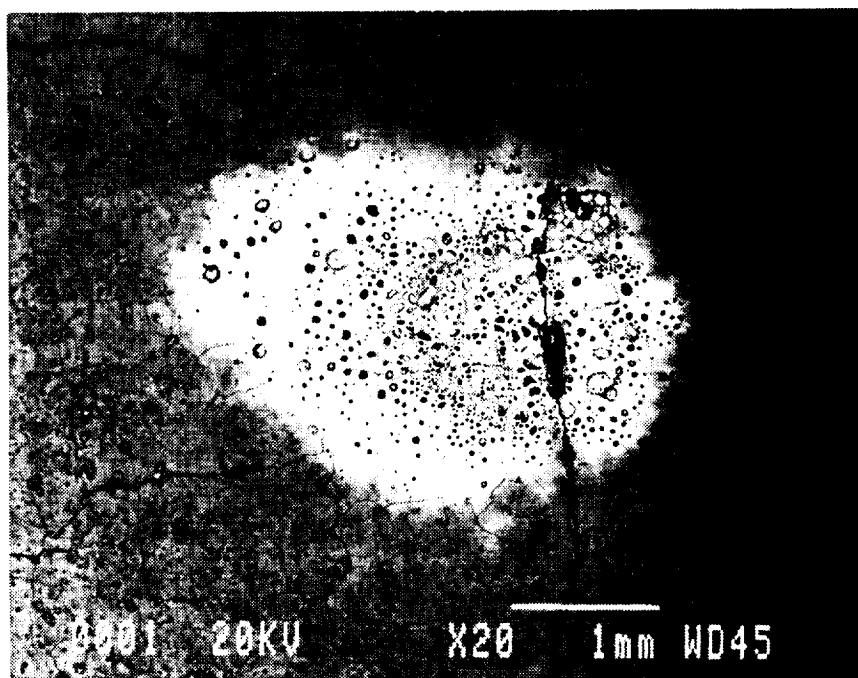
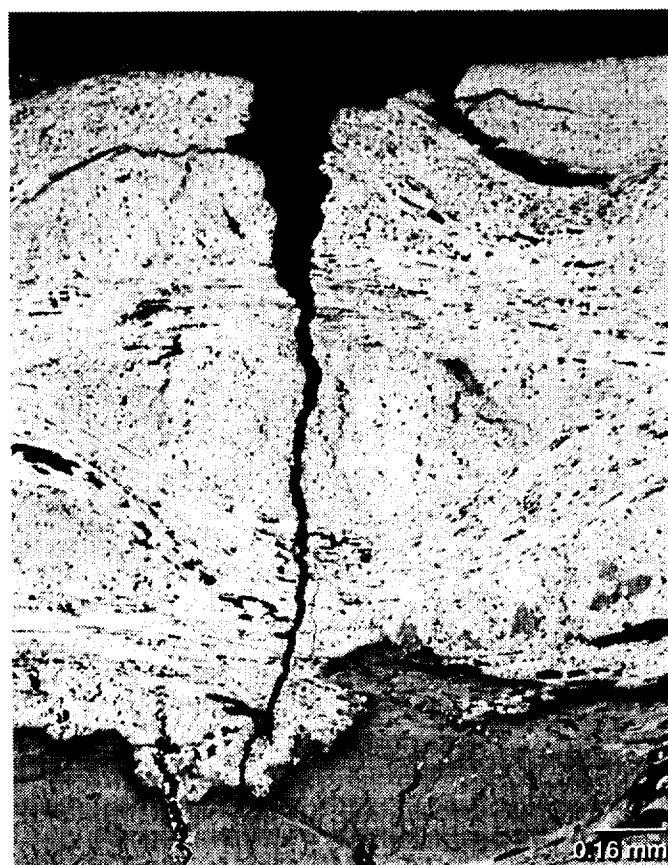
Figure 6.—Continued. (e) from OV-102, Wing Leading Edge Panel 10 LH, 19 flights. The cross-sectional view is an optical micrograph.

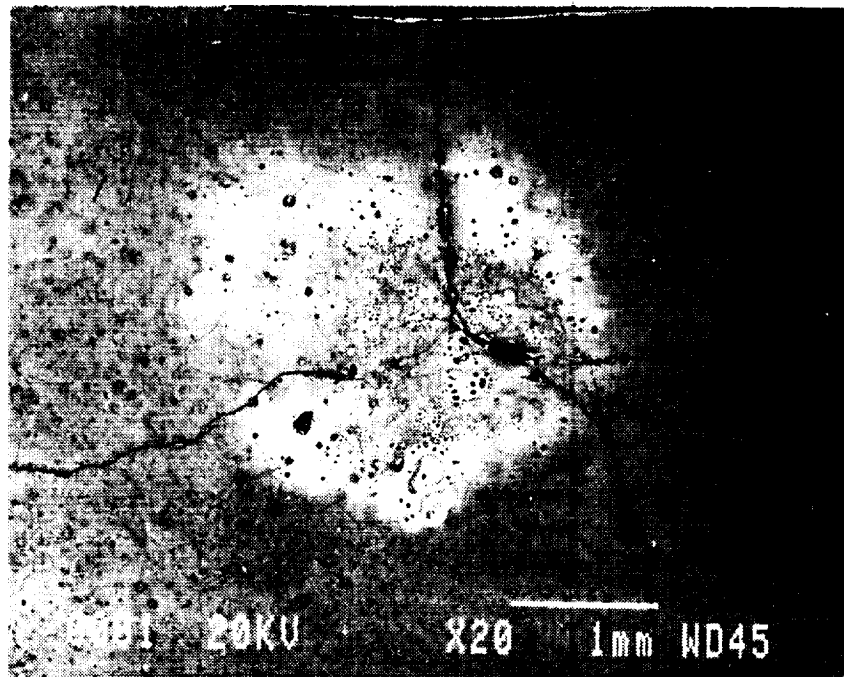
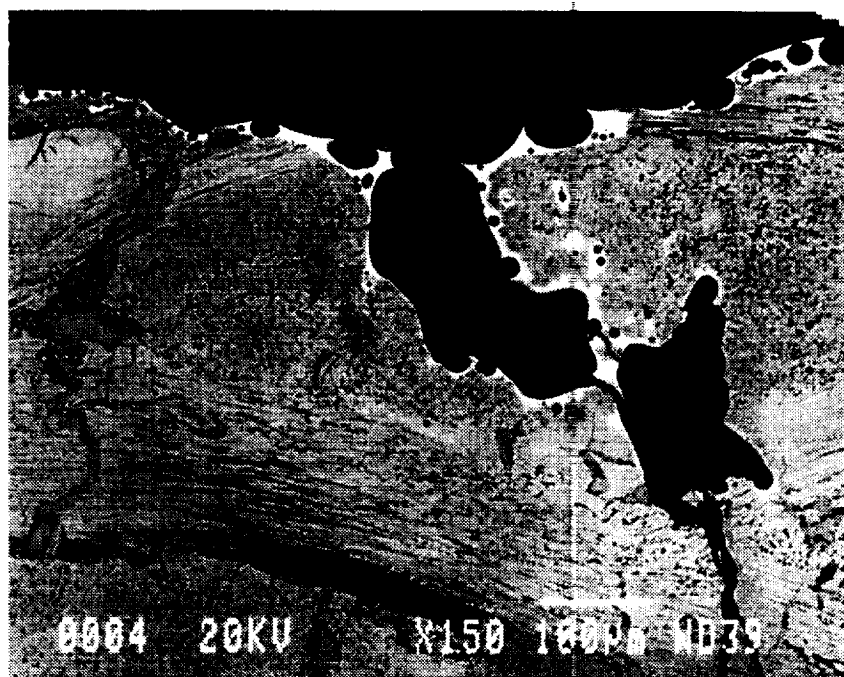
Figure 6.—Continued. (f) from OV-102, Wing Leading Edge Panel 10 LH, 19 flights. The cross-sectional view is a BSE micrograph.

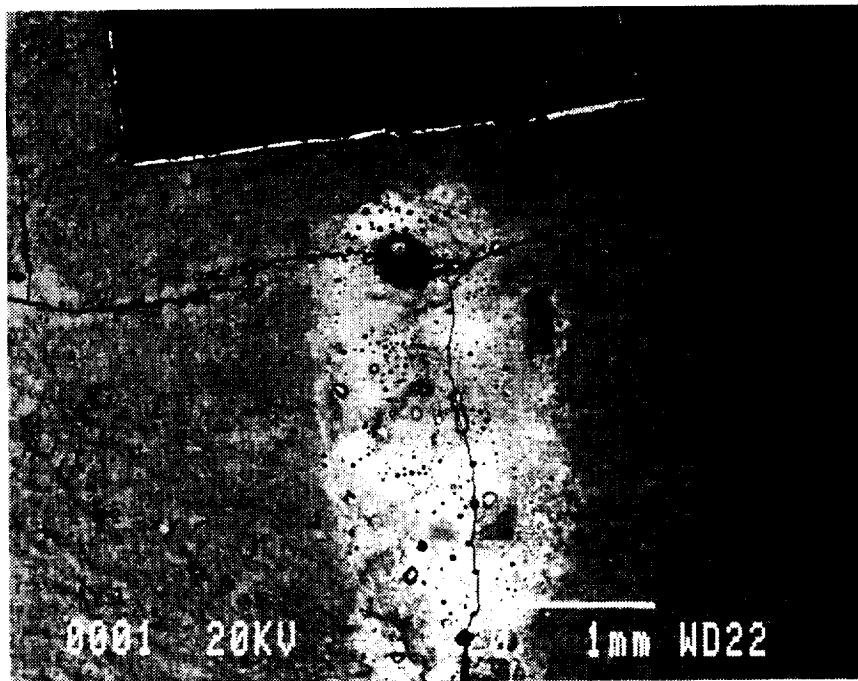
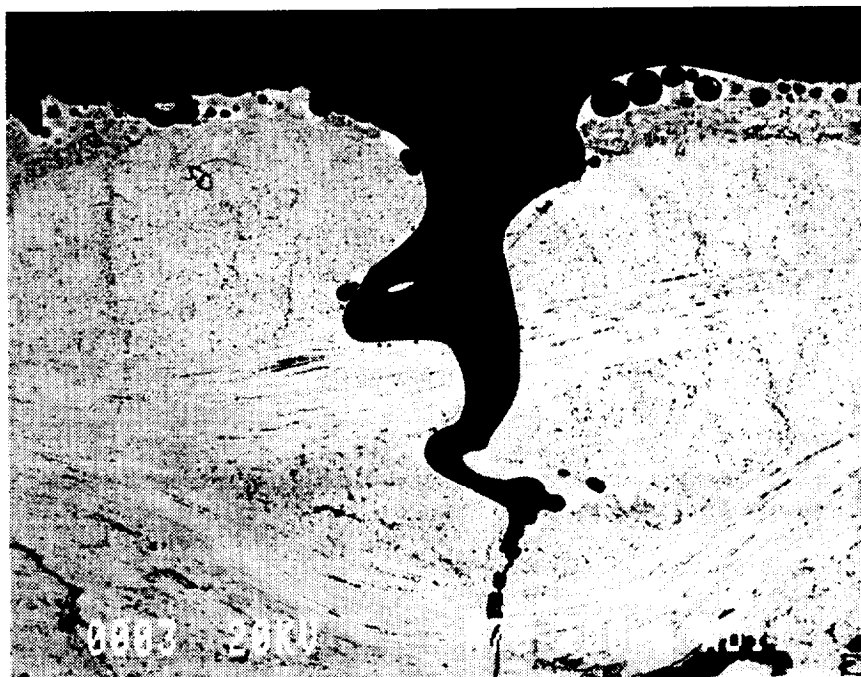
Figure 6.—Concluded. (g) Figures from OV-102, Wing Leading Edge Panel 10 LH, 19 flights. The cross-sectional view is a BSE micrograph.

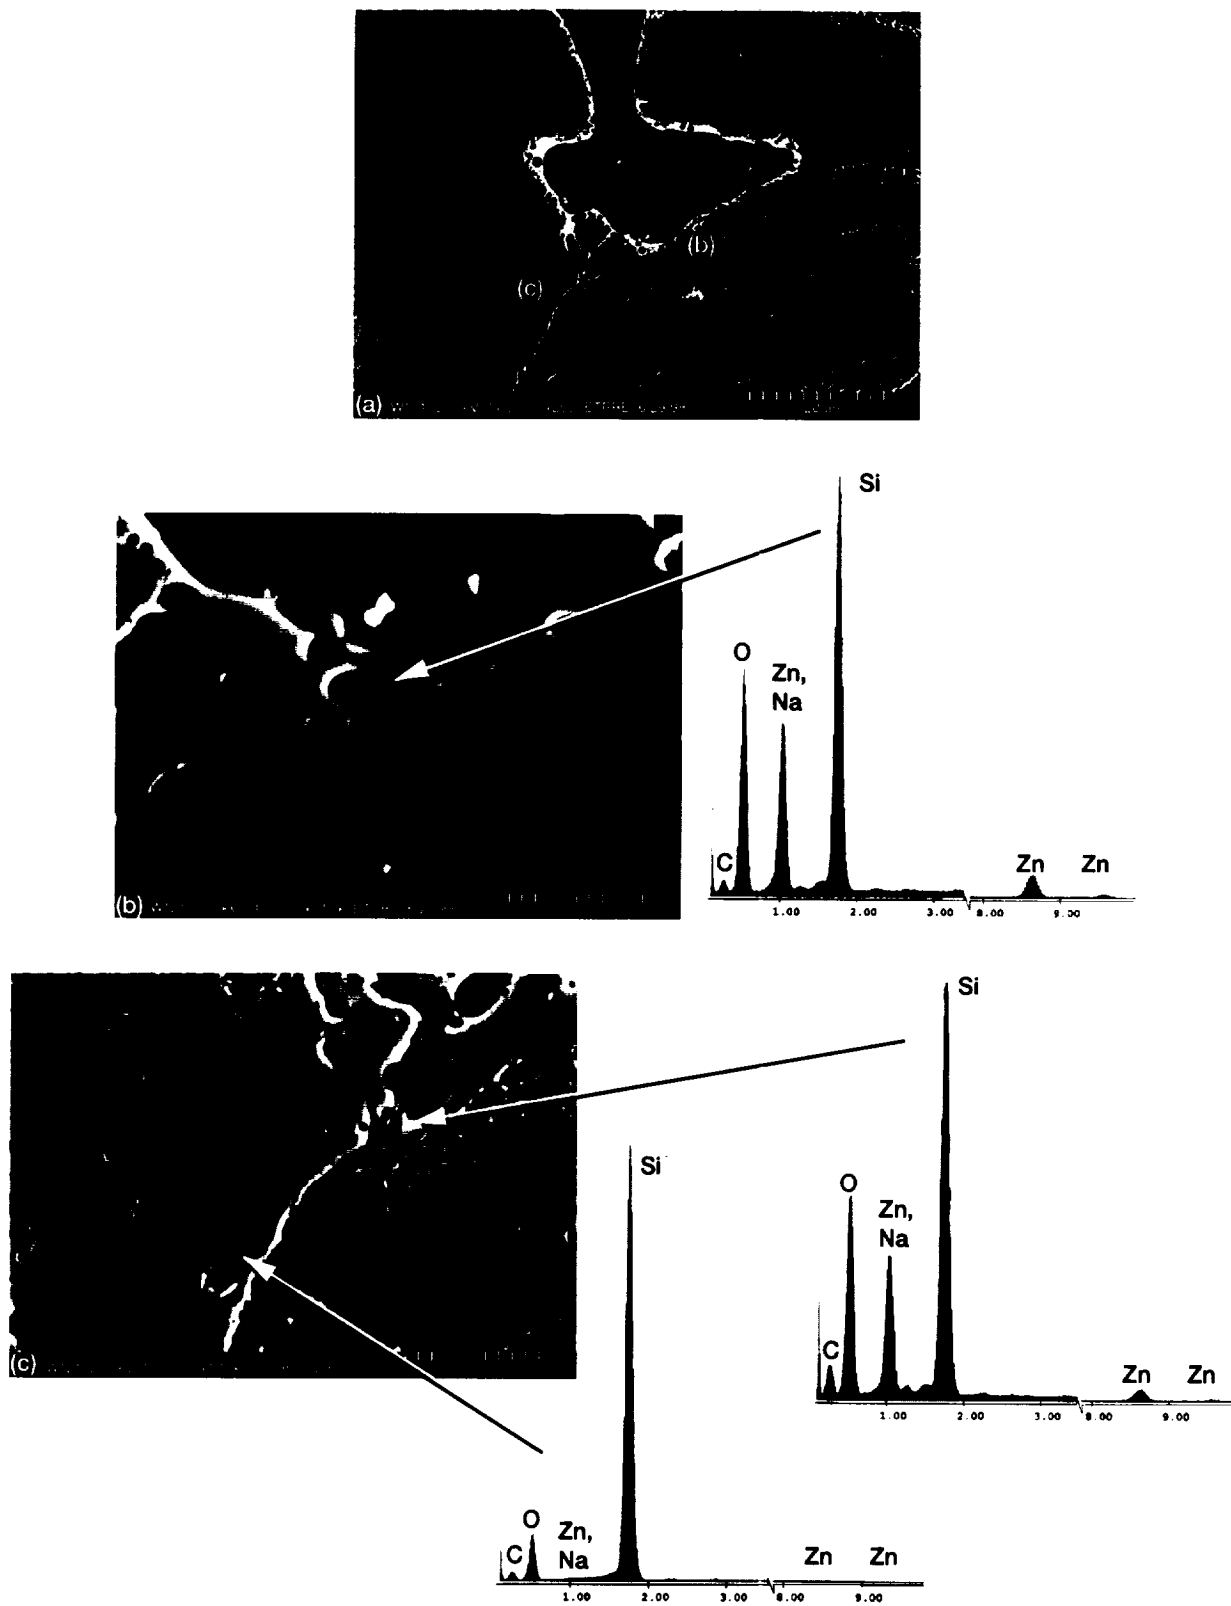
In this section, we present detailed microstructural examinations of the pinholes shown in figure 6. Figure 11 is a high magnification micrograph and associated EDS of figure 6(a). This was taken in the backscattered mode with our FEG-SEM. Note that the Na-Zn-Si-O glass only extends to the bottom of the enlarged crack. Below this, only a Na-Si-O glass is observed in the crack. Figure 12 is a 7000X magnification of a region of the glass in the enlarged part of figure 6(f). Three distinct layers are present in the glass and associated EDS spectra show a gradient in Zn. The inner most layer is nearly pure silica. The EDS spectra indicate a gradient in Zn concentration through the layers with the largest concentration on the outside. As discussed, Na and Zn peaks overlap in EDS spectra. In order to resolve these, WDS was taken of this glassy region. The SEM with the WDS attachment did not allow the three layers to be resolved. However a WDS spectrum of the entire glass region showed both Na and Zn (fig. 13). Typically such SiO_2 dissolution microstructures (ref. 2) show a pure layer of SiO_2 adjacent to the SiC and a decreasing gradient in Na from the gas/solid interface. Further, in this case, it is likely that both Na and Zn show similar gradients, decreasing toward the SiC/glass interface.

Figure 11.—(a) High magnification of photo of glass/SiC interface in a pinhole (full view is in Figure 6(a)) and associated EDS traces with regions (b) and (c). Note that Zn only extends to bottom of enlarged portion of crack.

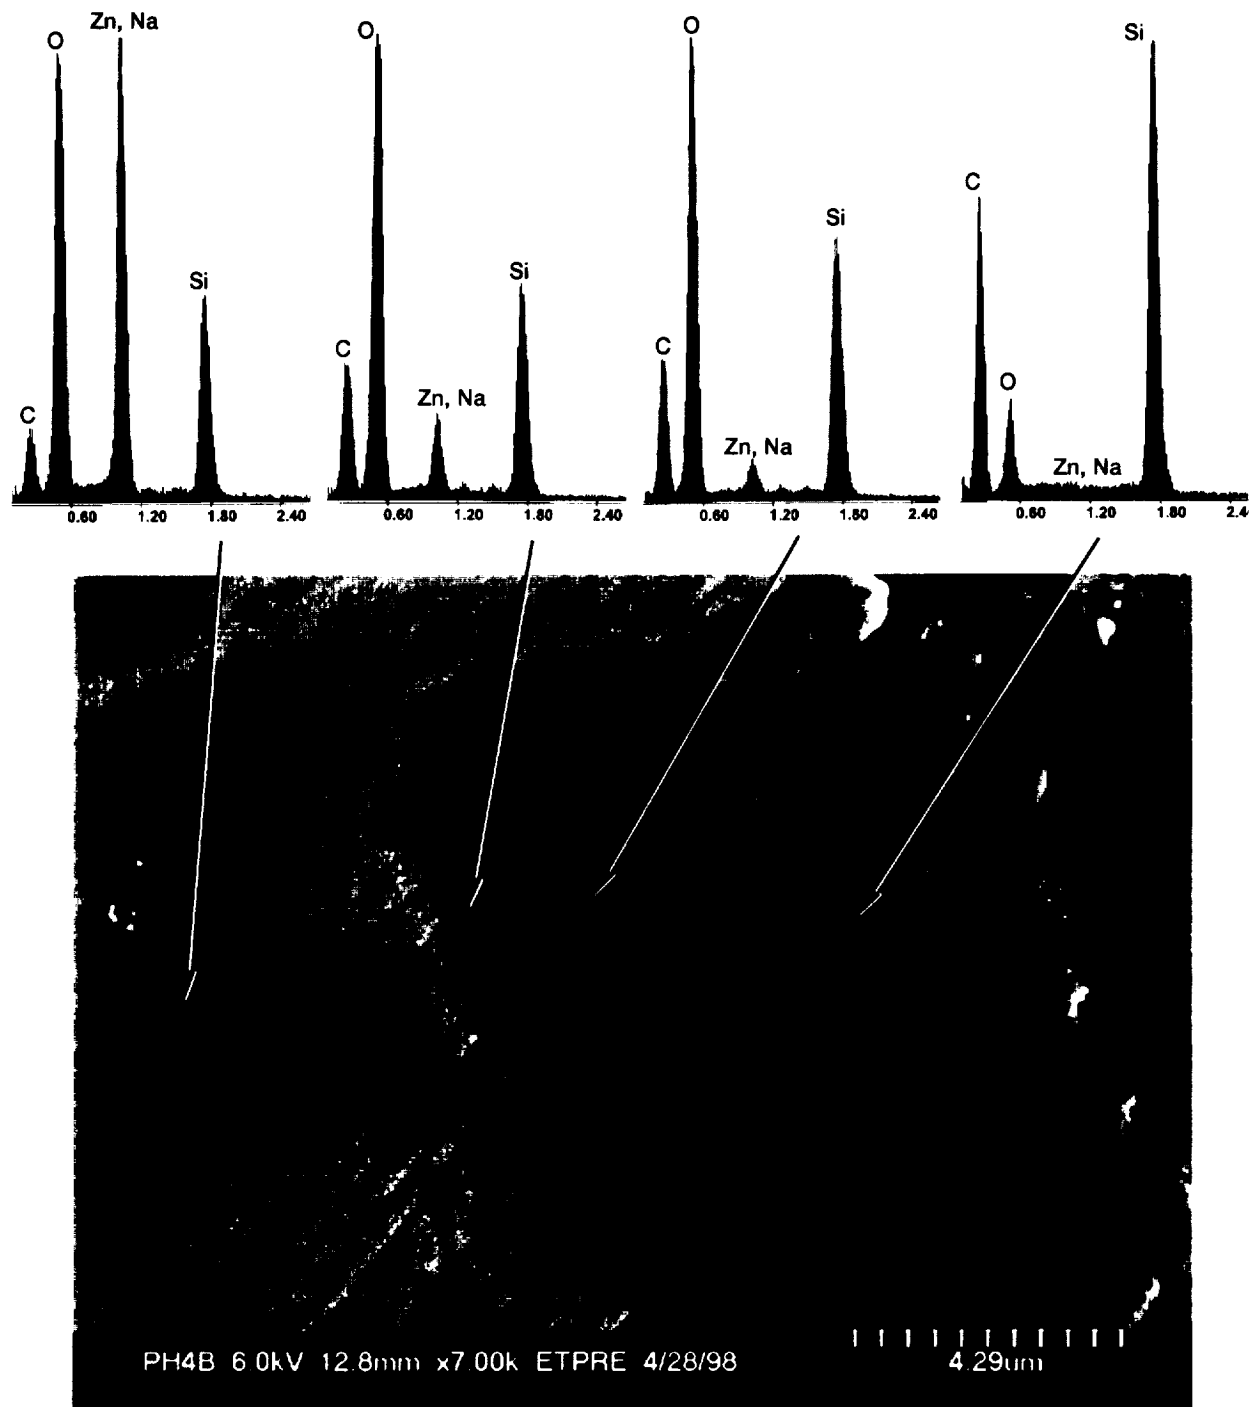
Figure 12.—High magnification photo of the glass/SiC interface in a pinhole (Figure 6(f)), showing composition at various points within the pinhole.
